## **Incident Report**

- Date of Incident: April 24th, 2024
- Time of Incident: Approximately 9pm local time
- Location: On-site at the shop area designated for vehicle installations, specifically outside the shop bays.

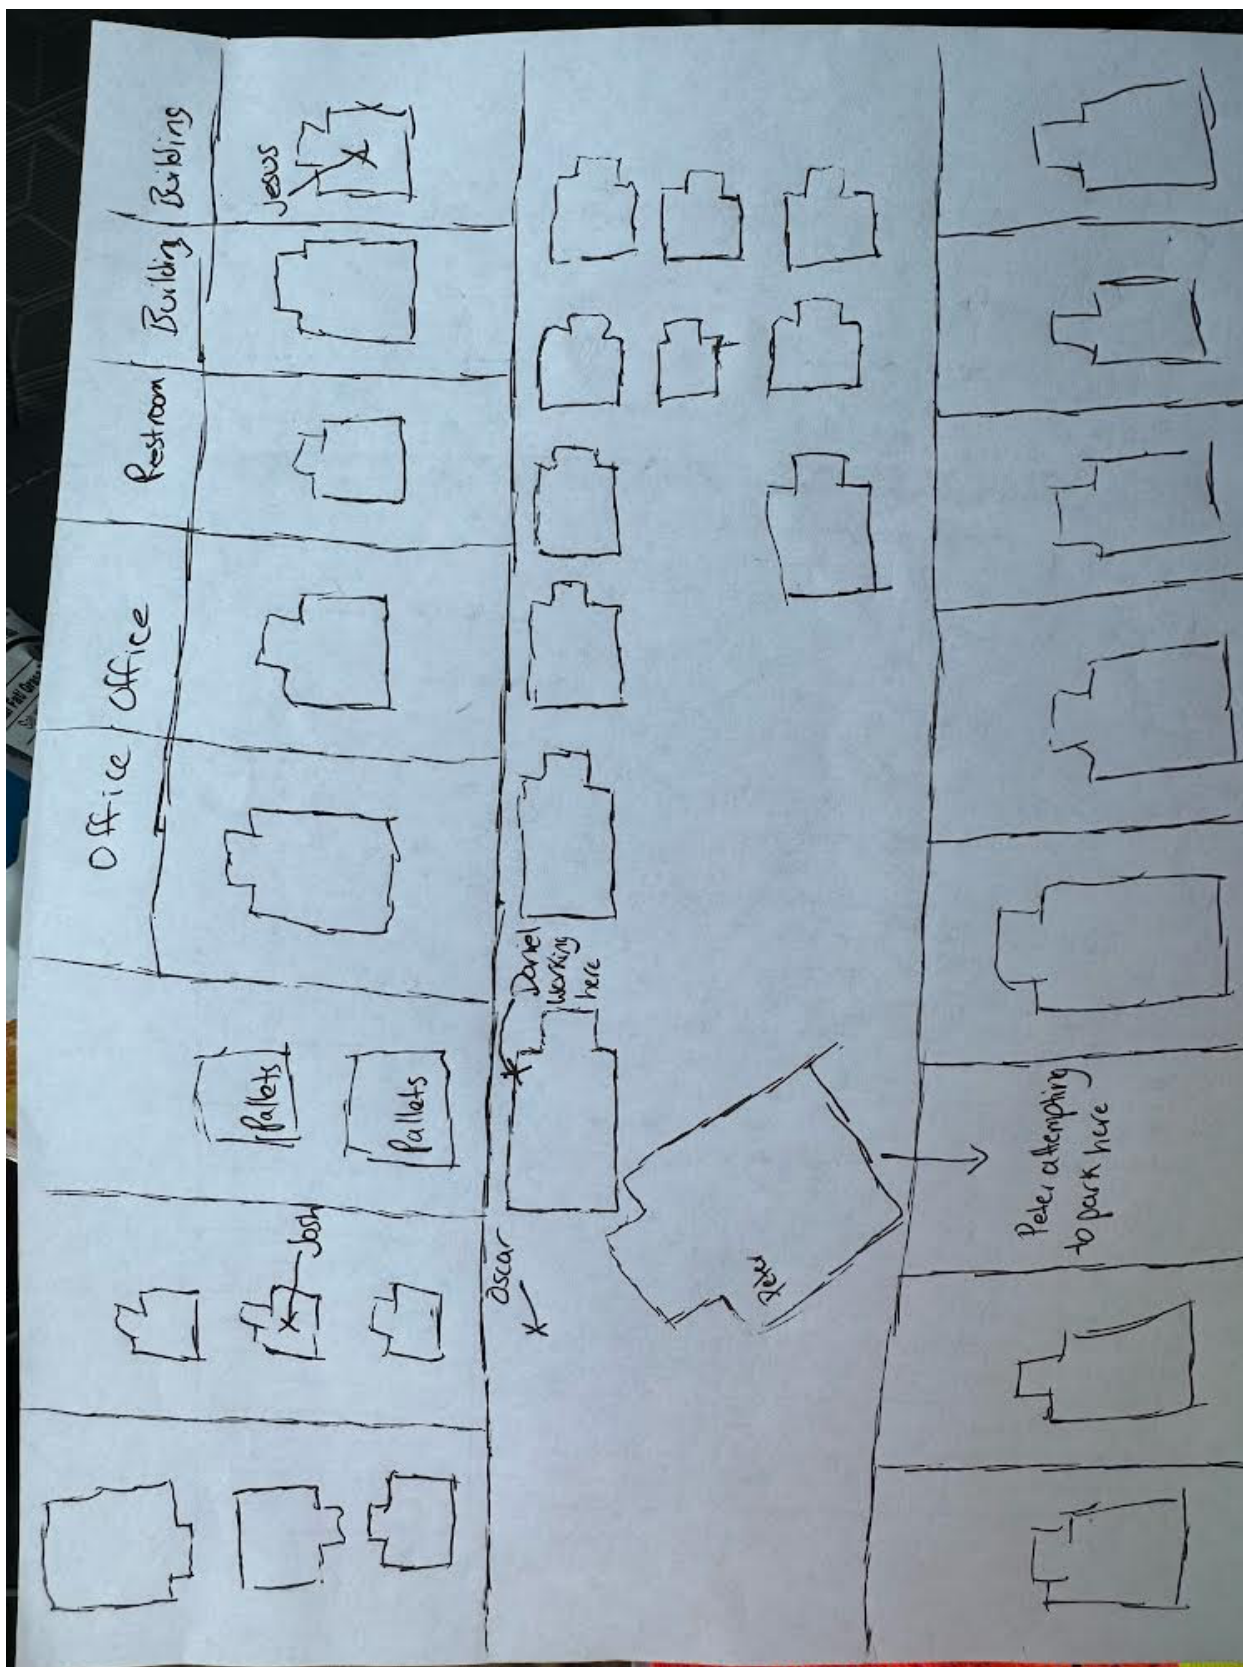
- Note the damage to the front bumper of the International

- Did you see how the third-party vehicle came into contact with the vehicle our employee was working on? I only saw the result of the damage on the bumper of the large truck. My view was obstructed by the jeep between me and the incident.
